SECTION 3

SITE AND BUILDING INSPECTION SUMMARY

EDUCATIONAL ADEQUACY ASSESSMENT

School: Auburndale Elementary School

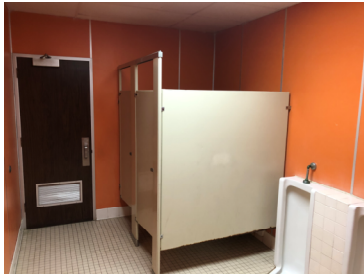
No ADA stall in the multi fixture toilet room

- 1) Replace door knobs with lever type hardware.
- 2) Replace railings that do not have the proper extensions at the stage
- 3) Provide wheelchair access to the stage
- 4) Provide an ADA stall in all multi fixture toilet rooms that do not currently have one
- 5) Replace the non-compliant toilet room sinks

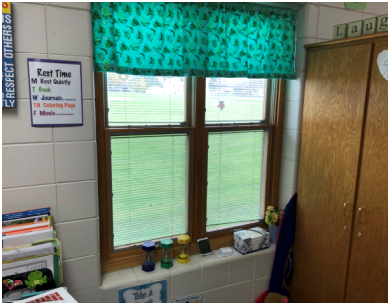
1998 Addition Windows

- a. *Expected life span 25-30 years for wood windows.*
- b. *Current Condition – Good/Poor*
- c. Older window frames are usually not thermally broken or do not contain high performance insulated glass. Glass performance has improved dramatically over the past 10-15 years and glass is designed to much better sun shading co-efficient (ability to block UV rays) and overall better R-Value. (Quality of thermal conductivity). Single pane or clear glass does not block UV rays or have any insulating value. Insulated glass that is tinted is also recommended to reduce glare as well.
- d. The windows at the 1958 portion of the building are original to the building and single pane
- e. The windows on the south side are original to the building.
- f. There is a mix of replaced and original windows around the building.

- 1). Replace all the original 1958 windows
- 2). Stay on maintenance schedule.

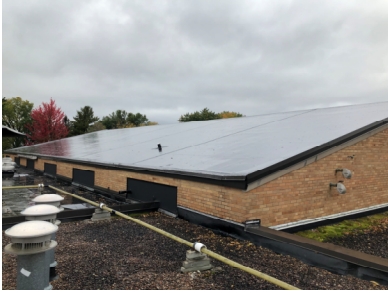
Roof at the Gym

- Expected life span 20 years for rubber EPDM, 30 years for Thermo-plastic, 40 years for built-up asphalt system*
- Current Condition – Good/Poor.*
- Portions of the roof were replaced however other portions have exceeded their expected life span

- 1) Replace the portions of the roof that have exceeded the expected life span
- 2) Stay on maintenance schedule.

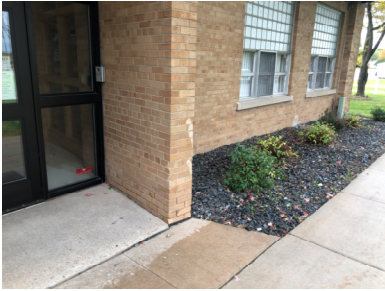
Damaged Brick at Corner

- a. *Expected life span of masonry 50 -100 years with periodic maintenance*
- b. *Current Condition - Good*
- c. Brick locations are in good condition, however there are areas with damaged bricks.
- d. The Precast exterior wall at the 1970's addition is in good condition
- e. There are masonry joints that need to be resealed with caulk
- f. *Expected life span of Exterior Finish Insulation System (EFIS) 25-30 years with periodic maintenance*
- g. *Current Condition - Fair*
- h. The EFIS system is approaching the end of its expected life span
- i. The metal panels are in fair condition, there are locations where the paint is beginning to peel off of them.

- 1) Replace, repair and tuckpoint brick walls as necessary.
- 2) Recaulk masonry joints
- 3) Replace the EFIS system as the maintenance costs increase
- 4) Repaint metal panels

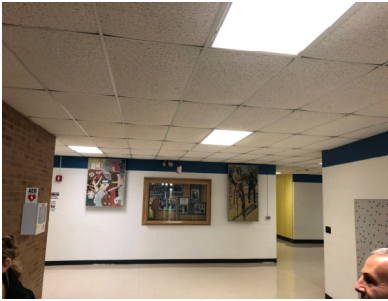
Typical 2'x4' Act Ceiling

- Expected life span 15 years*
- Current Condition – Good/Fair/Poor*
- The building has a mix of 2'x2' or 2'x4' Acoustical Lay in Ceilings (ACT), The 2'x4' ACT ceilings are generally in poor condition.
- The 1998 addition contains the 2'x2' ceiling tiles in good condition
- There are some areas of water damaged ACT ceiling tiles around the building
- Acoustical lay in ceilings (ACT) have tendency to sag over time and discolor.
- Ceiling grid discolors over time.
- New ceilings will increase light reflectance and give the space improved visual appeal.

- 1) Replace the poor 2'X4' ACT ceilings with 2'x2' ACT ceilings to match the new ceiling tiles throughout the building.
- 2) Replace the water stained ceiling tiles
- 3) Stay on a maintenance schedule.

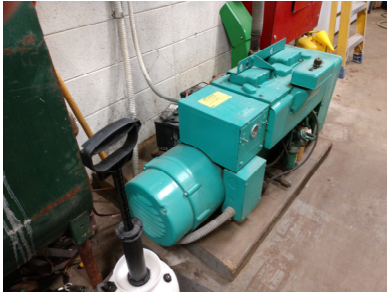
Generator

- a. *Expected life span 40 years.*
- b. *Current Condition - poor*
- c. An Onan 15kw generator is located in the boiler room to provide limited backup power to the building. The set is 120/208 volt three phase.
- d. The transfer switch is located adjacent to generator and is dated to the original generator.
- e. The generator appears to be vintage (1970s) and part of the 1970s addition.

- 1) Due to the age of the existing equipment, a plan should be in place to update the existing generator in the near future. This equipment typically has a useful life of 40 years. We estimated the age of the equipment to be 45 plus years. Any new generator should be located outside the facility and be natural gas-fired.
- 2) The generator loads must be separated into two sets of distribution to comply with codes; life safety and non-life safety loads. This will require two transfer switches and two panels.

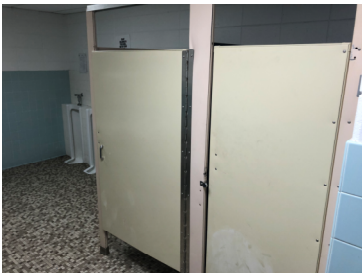
No ADA stall in the multi fixture
toilet room

- 1) Provide an ADA compliant path from the property line sidewalk to the entrance.
- 2) Replace door knobs with lever type hardware.
- 3) Replace railings that do not have the proper extensions
- 4) Provide wheelchair access to the stage
- 5) Provide an ADA stall in all multi fixture toilet rooms
- 6) Provide wheelchair access to the band and music room that meet code.

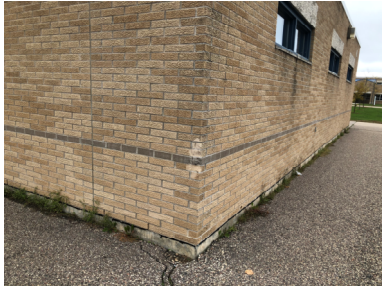
Damaged Brick at Corner

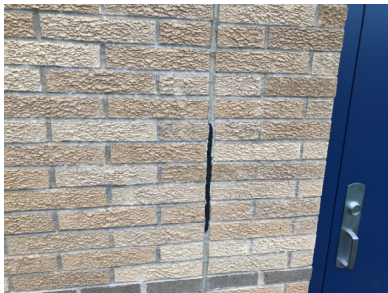
Damaged Caulk Joint

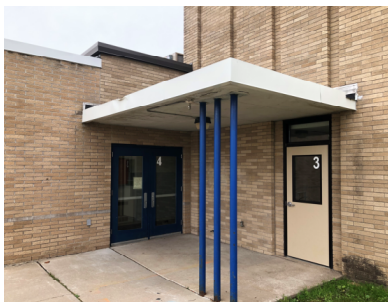
Rusted Columns and Damaged Fascia at Canopy

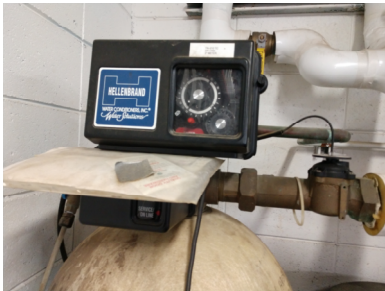
Water Softener

- a. *Life Expectancy – 10-15 years*
- b. *Current Condition – Good / Fair*
- c. Water Softener(s) –serving hot water system only.
 - i. 1qty. 75 gpm.
 - ii. Poor condition.
- d. Gas Water Heater(s)
 - i. 1qty. 100 gal.
 - ii. 120 degree storage temperature.
