SECTION 3

SITE AND BUILDING INSPECTION SUMMARY

EDUCATIONAL ADEQUACY ASSESSMENT

School: Auburndale Elementary School

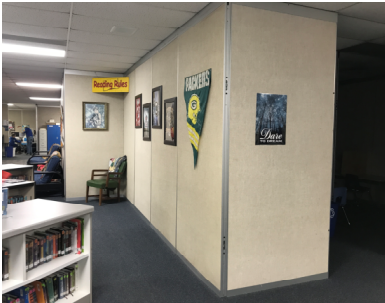
Temporary Wall Construction

- Building aesthetics and environment are not ideal for an elementary school. Movable walls and panelized wall system in gym/cafeeteria corridors contribute to a utilitarian/industrial building feel. New lighting and a more colorful paint scheme could help create a more age-appropriate educational environment.

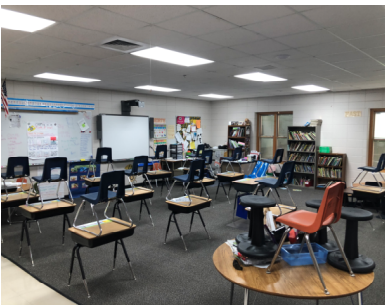
Typical Classroom Furniture

- Much of the furniture throughout the building is heavy and inflexible, which does not encourage reconfiguration for group work or collaborative learning.

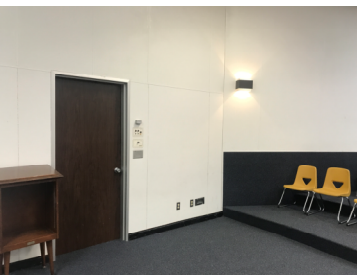
Knob Style door Hardware

- A. Many of the knob type door hardware have been changed to lever type but there are still a handful of knob type.
 - B. The handrails for the stairs to the stage do not have compliant extensions at the top or bottom of the stair.

- 1) Replace door knobs with lever type hardware.
- 2) Replace railings that do not have the proper extensions at the stage
- 3) Provide wheelchair access to the stage
- 4) Provide an ADA stall in all multi fixture toilet rooms that do not currently have one
- 5) Replace the non-compliant toilet room sinks

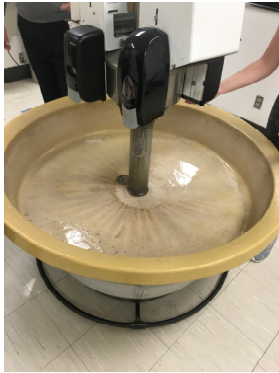
Non-ADA compliant Sink

5. Accessible restrooms (Entry and Turning Radius, Clearances, Fixtures, Grab Bars, Accessories)
 - A. Many of the toilet rooms have automatic door openers
 - B. The multi fixture toilet rooms in the 1970's portion of the building do not have ADA accessible stalls
 - C. The 1998 addition toilet rooms meet ADA and have accessible stalls
 - D. The circular hand sinks outside the toilet rooms at the cafeteria are not ADA compliant.

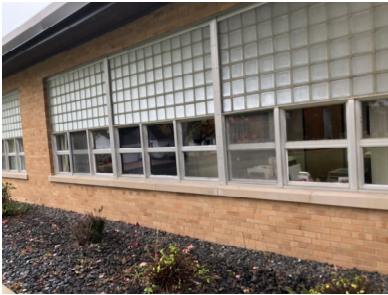
1958 Portion of the Building
Window

- a. *Expected life span 25-30 years for wood windows.*
- b. *Current Condition – Good/Poor*
- c. Older window frames are usually not thermally broken or do not contain high performance insulated glass. Glass performance has improved dramatically over the past 10-15 years and glass is designed to much better sun shading co-efficient (ability to block UV rays) and overall better R-Value. (Quality of thermal conductivity). Single pane or clear glass does not block UV rays or have any insulating value. Insulated glass that is tinted is also recommended to reduce glare as well.
- d. The windows at the 1958 portion of the building are original to the building and single pane
- e. The windows on the south side are original to the building.
- f. There is a mix of replaced and original windows around the building.

- 1). Replace all the original 1958 windows
- 2). Stay on maintenance schedule.

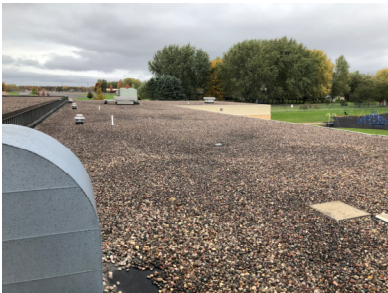
Roof at the 1970 portion of the Building

- Expected life span 20 years for rubber EPDM, 30 years for Thermo-plastic, 40 years for built-up asphalt system*
- Current Condition – Good/Poor.*
- Portions of the roof were replaced however other portions have exceeded their expected life span

- 1) Replace the portions of the roof that have exceeded the expected life span
- 2) Stay on maintenance schedule.

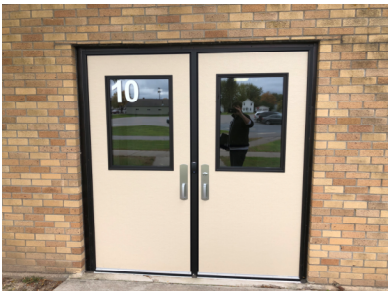
FRP Door Aluminum Frame

- Expected life span 20 years for steel, 30 years for aluminum/ FRP systems*
- Current Condition – Good/Fair*
- Most of the doors are Aluminum Frames with FRP Door leaf's, all in good condition
- There are a small number of hollow metal frames many of them are beginning to rust

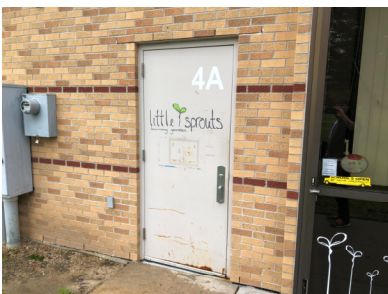
Hollow Metal Door and Frame

- 1) Stay on maintenance schedule.
- 2) Consider replacing the rusting hollow metal frame doors and frames with FRP doors and aluminum frames.

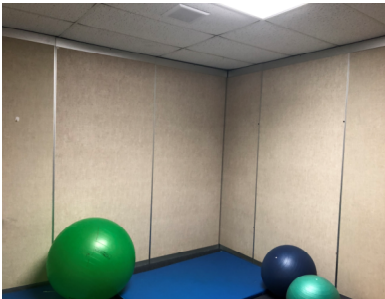
Demountable Partition

- Expected life span 50 -100 years with periodic maintenance*
- Current Condition – Good/Fair*
- There is a mix of CMU, Gypsum board, and demountable partition walls
- The CMU and gypsum walls are in good condition
- The Demountable partition walls are in fair condition and do not provide the same level of sound dampening as the other two wall types.

- 1) Stay on maintenance schedule.
- 2) As the movable partition walls become damaged from wear consider removing and replacing with fixed walls.

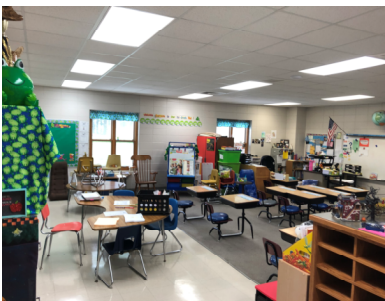
VCT and Carpet in a Classroom

- Expected life span VCT 20 years, carpet 10 – 15 years.*
- Current Condition – Good/Fair*
- Corridor flooring is mostly vinyl composition tile (VCT) and is in Good / Fair Condition.
- There are some areas around the library that have carpet in the corridor in fair condition
- The Classrooms are a mix off Carpet and vinyl composition tile (VCT) and in Good to Fair condition.
- The Library area is Carpet in Fair condition

- 1) Stay on a maintenance schedule
- 2) When the carpet is replaced consider changing to a carpet tile instead of broadloom. The carpet tile allows for replacement of stained portions of the carpet without replacing the entire floor.

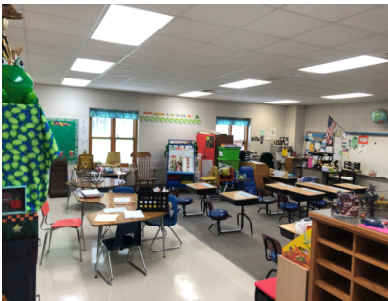
Typical 2'x2' Act Ceiling

- Expected life span 15 years*
- Current Condition – Good/Fair/Poor*
- The building has a mix of 2'x2' or 2'x4' Acoustical Lay in Ceilings (ACT), The 2'x4' ACT ceilings are generally in poor condition.
- The 1998 addition contains the 2'x2' ceiling tiles in good condition
- There are some areas of water damaged ACT ceiling tiles around the building
- Acoustical lay in ceilings (ACT) have tendency to sag over time and discolor.
- Ceiling grid discolors over time.
- New ceilings will increase light reflectance and give the space improved visual appeal.

- 1) Replace the poor 2'X4' ACT ceilings with 2'x2' ACT ceilings to match the new ceiling tiles throughout the building.
- 2) Replace the water stained ceiling tiles
- 3) Stay on a maintenance schedule.

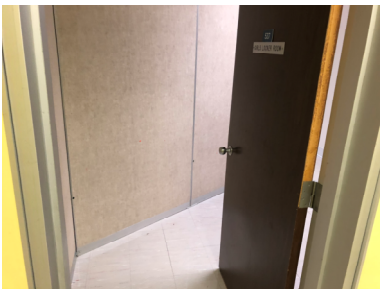
Door at the 1964 portion of the building

- Expected life span 40 years with periodic maintenance*
- Current Condition – Good/Fair*
- Door hardware is a mix of knob and lever type. The majority of the doors are lever but some knob type still exist in the older portions of the building
- Doors are wood in hollow metal frames. Wood doors in good/fair condition
- Many of the doors in the older portions of the building are in fair condition and have some wear consistent with there age.
- Due to the use and continued operation of interior wood doors the facing veneer will chip and tear over time and experience scrapes and dents.

- 1) Stay on a maintenance schedule
- 2) Replace door hardware with ADA compliant lever type.

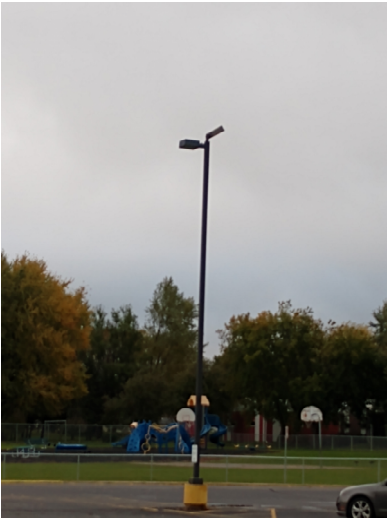
Exterior Pole Lighting

- a. *Life Expectancy – 20 years*
- b. *Current Condition – Good / Fair*
- c. All majority of the exterior lighting, both pole mounted and building mounted have been upgraded to LED by the district. Wall packs under soffit and building mounted flood lighting provides the building security lighting. Parking lot shoe box type fixtures were present to provide lighting in the parking lot. The district indicated they were going to finish updating any remaining fixtures to LED type. We did not walk through the facility during night time hours and could not verify the light levels, but recommend upgrading any remaining fixtures to LED type.

- 1) If the district does not finish the upgrade to LED lighting, we recommend fixtures be scheduled for upgrade.

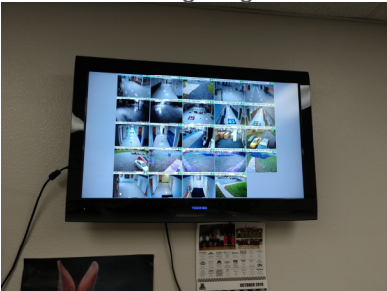
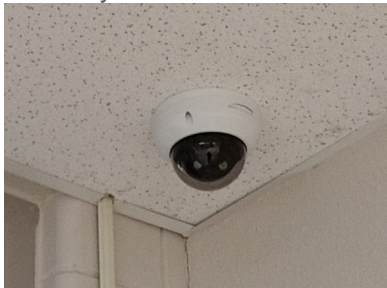
- a. *Life Expectancy – 15 years*
- b. *Current Condition – Good*
- c. The facility contains a CCTV system located in the office for interior and exterior cameras. An estimate of 15 total cameras for the facility were present. CCTV PerMar system is approximately 5 years old.

- 1) If additional cameras are added, extend existing camera system. The district would need to verify if there is a need for any additional cameras.

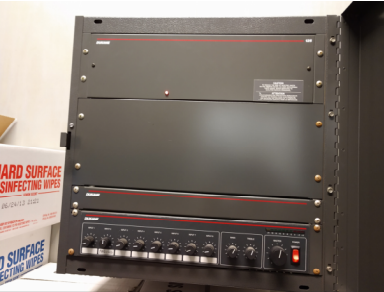
Intercom Head-end

- a. *Expected life span 30 -40 years with periodic maintenance*
- b. *Current Condition – Good to Fair*
- c. A Dukane system is located near the office. The system appears to be somewhat newer. The district indicates no issues with the system at this time.
- d. The existing Franklin Time System master clock is located near the office. The district indicates no issues with the system at this time.

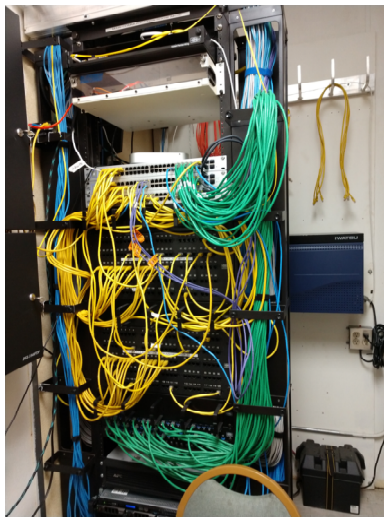
Data Rack

- a. *Expected life span 20 years.*
- b. *Current Condition – Good to Fair*
- c. The phone system for the elementary is IWATSU VOIP based. The facility contains wireless access throughout with adequate coverage. The classrooms and offices contained Cat 5 data drops. Existing data racks look to have some room for expansion. One IDF rack is an open wall mounted type. The MDF is a floor mounted open rack.

- 1) If new drops are added in the building, there appears to be room for additional drops depending on number of drops requested by the district. Proper grounding should be added and new Cat 6 cabling provided

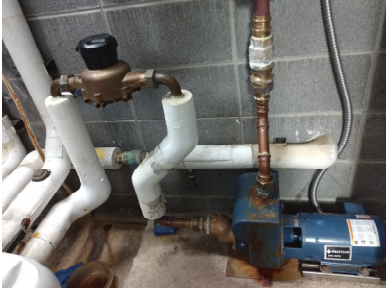
Water Service

- a. *Expected life span 15-20 years.*
- b. *Current Condition – Fair*
- c. The water service is a 1" copper with a 1" water meter.
- d. Pressure booster pump is non-VFD without a pressure tank.
- e. Piping system material is Copper.
- f. Domestic cold water hard piping system is in fair condition.
- g. Domestic hot water supply piping system is in fair condition. Hot water delivery wait time to fixture is over 90 seconds.
- h. Domestic hot water return piping system is in fair condition.
- i. Water pressure is in fair condition. Actual pressure 45-65.
- j. The system relies on a booster pump for normal operation. The existing pressure booster pump is non-VFD without a pressure tank. It is in fair condition.
- k. Water is softened for the hot water system only.
- l. Backflow preventers serving boiler are in fair condition.

- 1) Backflow preventers shall be maintained / repaired as required and tested once a year.
- 2) Water testing shall be acquired to determine water quality and proper treatment of equipment.
- 3) The existing galvanized piping shall be replaced with new copper or approved piping material.
- 4) Repair all leaks on piping as required with new copper or approved piping material.
- 5) Provide new pipe insulation as required on exposed and damage piping areas & sections.
- 6) Provide complete new properly sized domestic water piping system with new copper or approved piping material for any addition or remodeled area per new energy codes concerning hot water distance to faucets for hand washing.
- 7) Extend and balance hot water return and supply piping to fixtures to improve hot water delivery wait time.

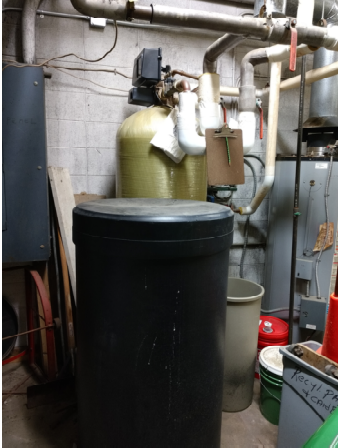
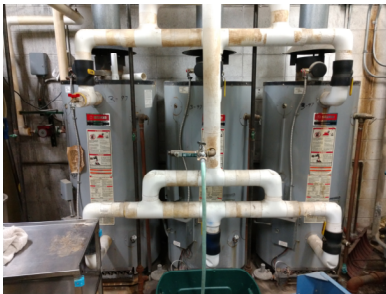
- a. *Life Expectancy – 2-5 years*
- b. *Current Condition – Fair*
- c. Water Softener(s).
 - i. 1qty. 75 gpm.
 - ii. Poor condition
- d. Gas Water Heater(s).
 - i. 3qty. 80 gal.
 - ii. 120 degree storage temperature.
 - iii. Poor condition.

- e. Circulator Pump.
 - i. 1qty. 3 gpm.
 - ii. Poor condition.

- 1) Provide complete new domestic hot water heating plant equipment.
- 2) Provide new high efficiency gas water heaters or boiler with storage tank. Temperature storage shall be 135 degrees per ASPE recommendation with master thermostatic mixing valve for 120 degree outlet temperature.
- 3) Provide new circulating pumps and associated valves.
- 4) Provide new expansion tank.
- 5) Re-balance hot water distribution system.

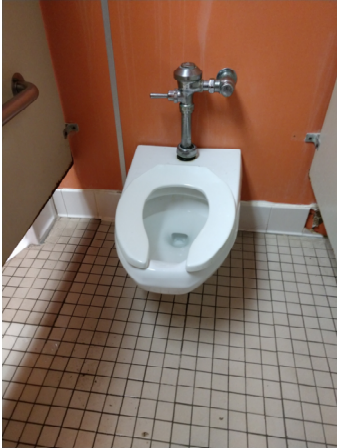
Water Closet

- a. *Life Expectancy – 5-10 years*
- b. *Current Condition – Fair*
- c. Water Closets are mixture of floor mount with flush valve and wall mount with flush valve fixtures. Flush valves are manual lever operated. The majority of the fixtures are in fair condition and ADA compliant.

- 1) Provide sensor operated flush valves and faucets in toilet rooms.
- 2) Provide all new plumbing fixtures and trim accessories.
- 3) Provide wall mounted fixtures where possible in toilet rooms.

- 4) Provide floor drains with trap seal protection in all toilet rooms.
- 5) Replace non ADA complaint fixtures with ADA complaint fixtures.
- 6) Provide solid interceptors at art sink.

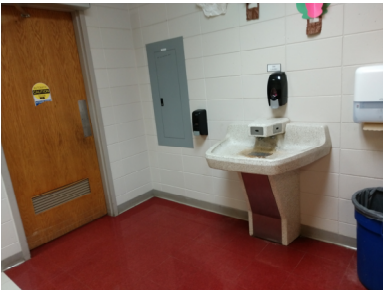
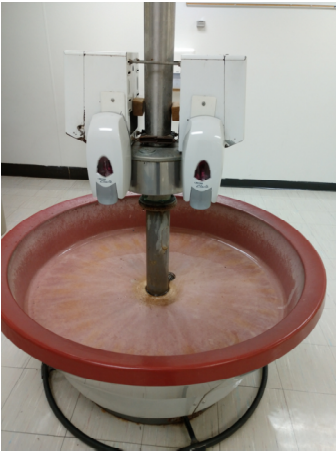
- e. Wash fountains are circular type fixtures. Faucets are foot manual lever operated. The majority of the fixtures are in poor condition and not ADA complaint.

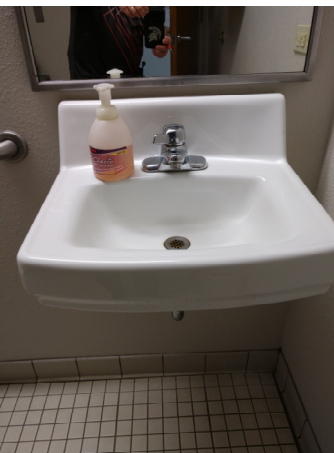
Lavatory

- d. Lavatories are mixture of wall mount fixtures. Faucets are manual lever operated. The majority of the fixtures are in fair condition and ADA complaint.

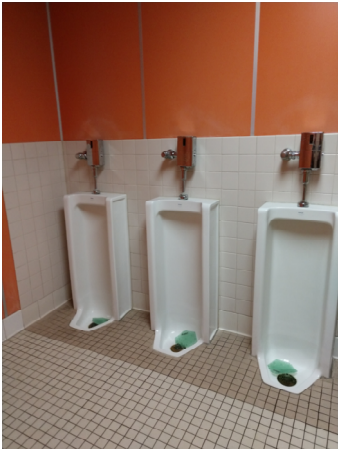
- f. Urinals are floor mount with flush valve. Flush valves are sensor hard wired and sensor battery operated. The majority of the fixtures are in fair condition and ADA complaint.

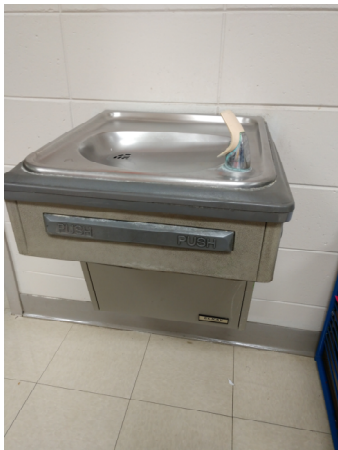
Electric Water Cooler

- g. Electrical Water Coolers are a mixture with and without bottle filling stations. The majority of the fixtures are in fair condition and ADA complaint.

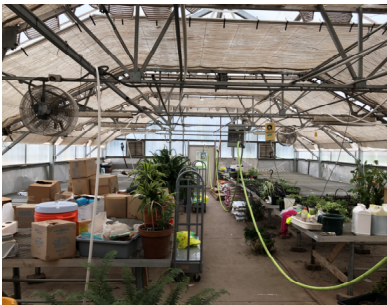
Greenhouse

- The greenhouse is in poor condition.
- There are accessibility concerns for those with mobility impairments in many of the restrooms, at the stage area, the FACE lab, and in the band room.

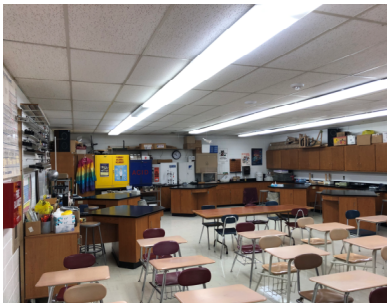
Science Classroom

- Science classrooms are inflexible and outdated. Some of the lab equipment no longer aligns with current program offerings. A redesign of these areas would allow for more efficient and multi-functional use of the space.

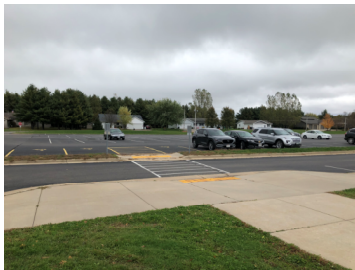
ADA path from parking lot

1. Accessible Route from Property Line to Main Entry (grade slope, walks, curb ramps, etc.)
 - A. There is a side walk along the property line at the street but no connection to the sidewalks within the school property. You would need to walk from the property line down the drive to reach a sidewalk connecting to the main entrance.

- 1) Provide an ADA compliant path from the property line sidewalk to the entrance.
- 2) Replace door knobs with lever type hardware.
- 3) Replace railings that do not have the proper extensions
- 4) Provide wheelchair access to the stage
- 5) Provide an ADA stall in all multi fixture toilet rooms
- 6) Provide wheelchair access to the band and music room that meet code.

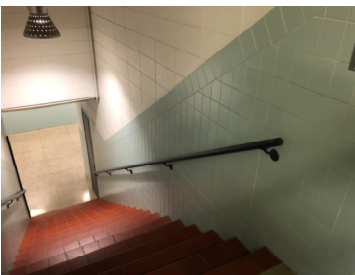
Non-compliant railing

- B. The handrails for the stairs in the original building do not have compliant extensions at the top or bottom of the stair.

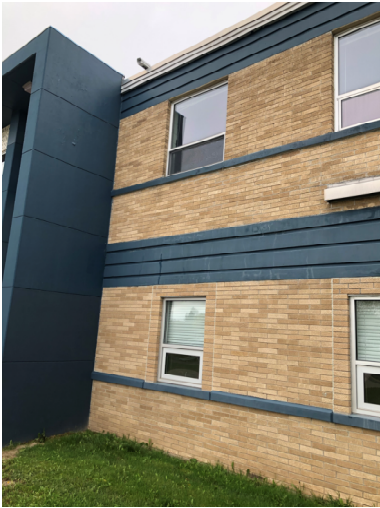
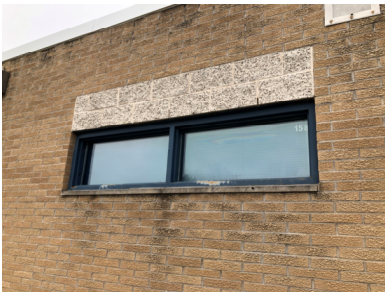
- a. *Expected life span 25-30 years for aluminum windows.*
- b. *Current Condition – Good/Fair/ Poor*
- c. Older window frames are usually not thermally broken or do not contain high performance insulated glass. Glass performance has improved dramatically over the past 10-15 years and glass is designed to much better sun shading co-efficient (ability to block UV rays) and overall better R-Value. (Quality of thermal conductivity). Single pane or clear glass does not block UV rays or have any insulating value. Insulated glass that is tinted is also recommended to reduce glare as well.
- d. There is a set of Hollow Metal window frames at the east side of the building that have areas of rust.
- e. The windows on the south side are original to the building.
- f. There is a mix of replaced and original windows around the building.

- 1). Replace the Hollow metal windows on the east side of the building.
- 2) Replace all the original 1964 windows
- 3) The windows in the 1993 addition have reached the end of their expected lifespan consider replacing them as the maintenance needs increase.

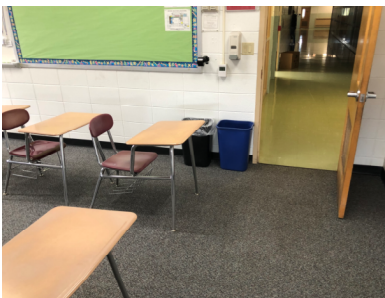
Typical Classroom Carpet

- a. *Expected life span VCT 20 years, carpet 10 – 15 years.*
- b. *Current Condition – Good/Fair/Poor*
- c. Corridor flooring is either Terrazzo or vinyl composition tile (VCT) and is in Good / Fair / Poor Condition
- d. The corridor in the 1998 addition is ceramic tile in good condition.
- e. The Classrooms are a either Carpet or vinyl composition tile (VCT) and in Good to Fair condition.
- f. The 1964 building has some originally vinyl asbestos tile (VAT). Some areas have been renovated to a VCT however some areas still contain VAT which is in fair/poor condition.

- 1) Replace VAT (asbestos tile) flooring. Replace wall base as well which is typical when flooring is replaced.
- 2) When the carpet is replaced in the classrooms consider changing to a carpet tile instead of broadloom. The carpet tile allows for replacement of stained portions of the carpet without replacing the entire floor.

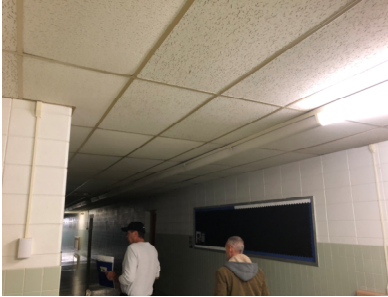
Typical 2'x4' Act Ceiling

- a. *Expected life span 15 years*
- b. *Current Condition – Good/Fair/Poor*
- c. The building has a mix of 2'x2' or 2'x4' Acoustical Lay in Ceilings (ACT), The 2'x4' ACT ceilings are generally in poor condition.
- d. There are some areas of water damaged ACT ceiling tiles around the building
- e. Acoustical lay in ceilings (ACT) have tendency to sag over time and discolor.
- f. Ceiling grid discolors over time.
- g. New ceilings will increase light reflectance and give the space improved visual appeal.

- 1) Replace the poor 2'X4' ACT ceilings with 2'x2' ACT ceilings to match the new ceiling tiles throughout the building.
- 2) Replace the water stained ceiling tiles
- 3) Stay on maintenance schedule.

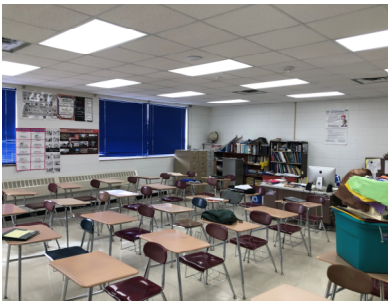
Typical 2'x2' Act Ceiling

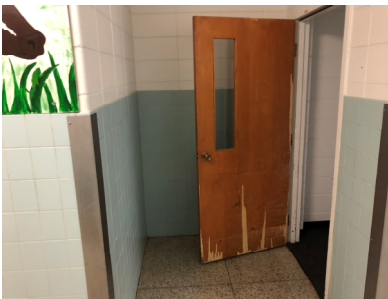
Door at the 1964 portion of the building

- a. *Expected life span 40 years with periodic maintenance*
- b. *Current Condition – Good/Fair/Poor*
- c. Door hardware is a mix of knob and lever type.
- d. Doors are wood in hollow metal frames. Wood doors in good/fair/poor condition
- e. Many of the doors at the 1964 portion of the building have large portions of the veneer removed
- f. Due to the use and continued operation of interior wood doors the facing veneer will chip and tear over time and experience scrapes and dents.
- g. Metal door frames can be repaired and painted while various hardware components can be replaced. Door chips and scratches can be sanded, filled and restrained to revive an old door. Depending on severity of door or frame damage, it may be cost effective to replace the entire door and frame.

- 1) Replace door hardware with ADA compliant lever type.
- 2) Replace the door leafs at the severely damaged doors.

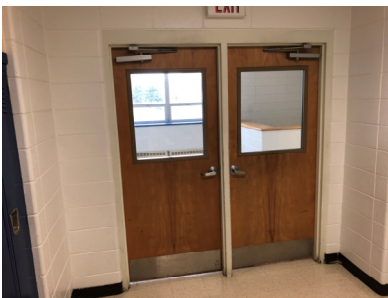
Door at the 1993 portion of the building

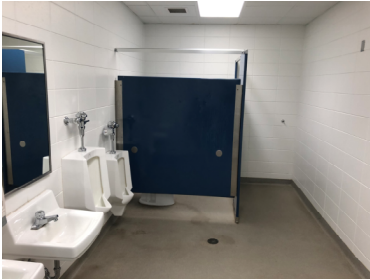
Toilet room in the locker room

- a. *Current Condition – Good/Fair*
- b. *Refer to ADA report for accessibility recommendations.*
- c. Ceramic Floor Tile (expected life span 40 years) – Good/Fair. Older grout holds bacteria.
- d. Ceramic Wall Tile (expected life span 40 years) Good/Fair. Older grout holds bacteria and there are locations with chipped tile.
- e. Toilet Partitions (metal) -(expected life span 15 years) Good/Fair/Poor
- f. Many of the partitions at the 1964 toilet rooms are in poor condition
- g. Accessories – (expected life span 8-10 years) good, provided by vendors.

- 1) 1964 restrooms: Remove and replace all wall and floor tile with new.
- 2) Replace toilet partitions with anti-graffiti plastic type.

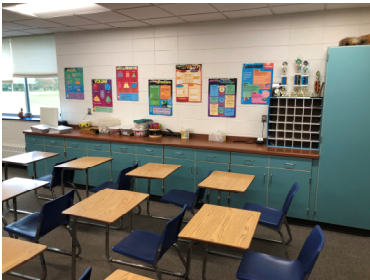
1993 Addition Casework

- a. *Expected life span 20-25 years*
- b. *Current Condition – Good / Fair*
- c. Cabinets appear to be original to building.
- d. The cabinets have reached the end of there expected lifespan in the original and 1993 addition.

- 1) Replace cabinetry and countertops as needed.

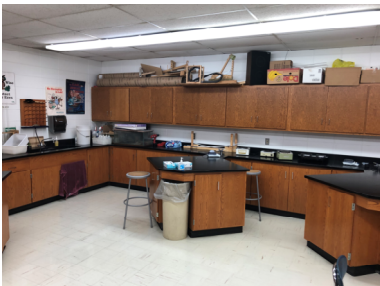
Science Casework

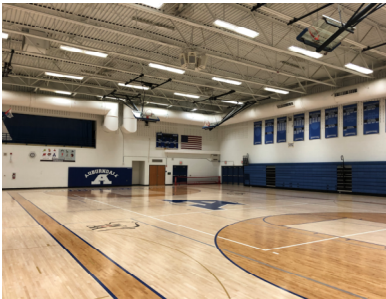
- a. Basketball backboards and wall supports are in good condition.
- b. Flooring – wood athletic flooring
- c. The Bleachers are in good condition

Addition Gym

- 1) Stay on maintenance schedule.

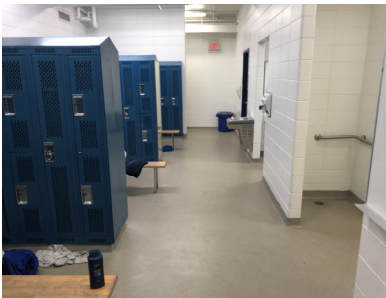
- a. Steel lockers are in good condition.

Typical Locker Room

- 1) Stay on maintenance schedule.

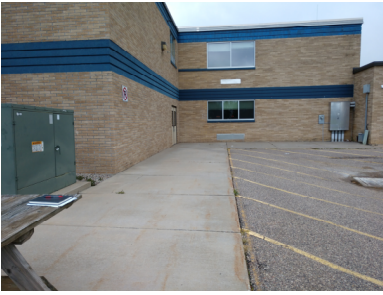
Transformer and Entrance

- a. *Expected life span 30-40 years.*
- b. *Current Condition – Good*
- c. This building is fed from a 300KVA 277/480 volt 3 phase 4 wire ground mounted transformer. This feeds into a wall mounted C/T cabinet via underground conduits into a main disconnect that feeds a fusible switch section with fusible buckets that feed loads throughout the facility. The service dates to the original construction of this building.
- d. This building also has a 120/208 volt 3 phase 4 wire ground mounted transformer on the north side of the facility. This feeds a wall mounted C/T cabinet via underground conduits. This feeds panel “PPA” in gym storage room. It appears to be added with the 2000 building addition.

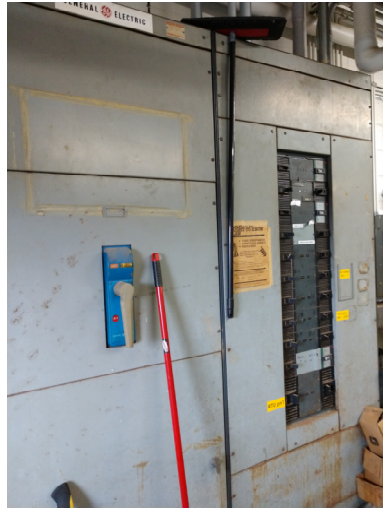
Main Switchboard

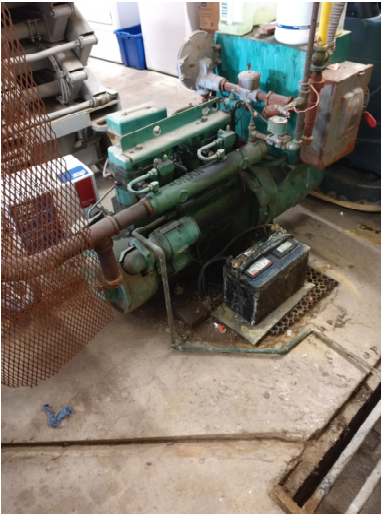
Generator

- a. *Expected life span – 40 years.*
- b. *Current Condition – Poor*
- c. An Onan LP generator is located in the boiler room to provide limited backup power to the building. The set is 120/208 volt three phase.
- d. The transfer switch is located adjacent to generator and is dated to the original generator.
- e. The generator appears to be vintage (1960's).

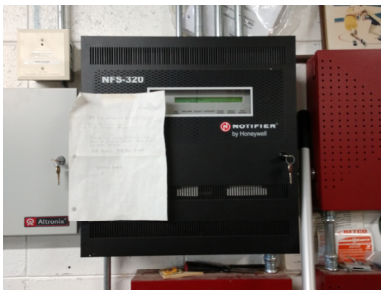
Fire Alarm Control Panel

- a. *Current Condition - Good*
- b. The system is a Notifier addressable panel located in boiler room. PerMar installed this system within the last 5-8 years. There is no dialer present. System does not present any issues at this time.

- 1) Additional horn and strobe devices can be added to all occupied areas to bring the system up to complete code compliance. This will require a more in-depth study to determine the areas that need additional equipment added. The system is addressable and devices can be added to the existing system.

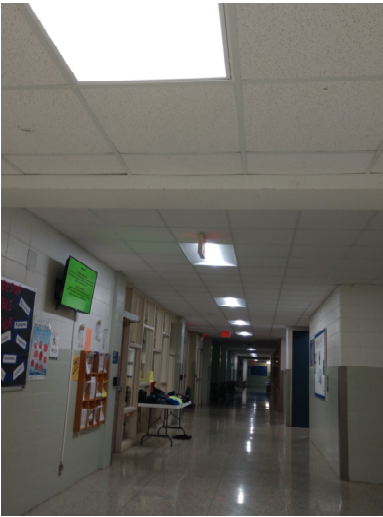
Corridor Lighting

- a. *Life Expectancy – 20 years*
- b. *Current Condition – Good/Fair*
- c. Approximately 50% of the facility lighting has been upgraded to LED by the district. This process has been a lamp/driver replacement only with the fixture housing remaining in place. Exit lights appear to be LED type. The gym lighting fixture lamps appear to have been upgraded to LED. We did note areas of the corridors where exit lights were not present in need of replacement.
- d. There appears to be areas of the building that have separate dual and single head emergency fixtures.

- 1) Any of the interior lighting that has not been upgraded to LED should be scheduled for upgrading. This would add to the efficient LED lighting that has already been replaced. Replacement of any existing switches to dimmers to control LED fixtures. Replacement of any damaged fixtures, IE exit lights.
- 2) Remove existing dual and single head emergency fixtures and re-circuit corridor lighting to be controlled via emergency generator to provide code compliant emergency egress lighting.

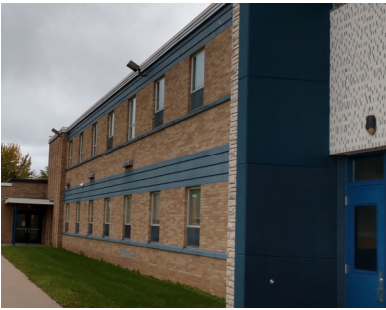
Exterior Lighting

- a. *Life Expectancy – 20 years*
- b. *Current Condition – Good / Fair*
- c. The majority of the exterior lighting, both pole mounted and building mounted, have been upgraded to LED by the district. Wall packs, under soffit and building mounted flood lighting provide the building security lighting. Parking lot shoe box type fixtures were present to provide lighting in the parking lot. The district indicated they were going to finish updating any remaining fixtures to LED type. We did not walk through the facility during night time hours and could not verify the light levels, but recommend upgrading any remaining fixtures to LED type.

- 1) If there are fixtures that need upgrading, we recommend this work to be completed. The new IBC codes dictate that emergency exterior egress lighting be installed outside each code required egress exit. Due to the age of this facility, it currently does not meet code in regards to exterior egress lighting. This facility is grandfathered in and does not require it, however, if new LED type lighting is provided to

replace the existing fixtures, we would recommend updating to meet current code.

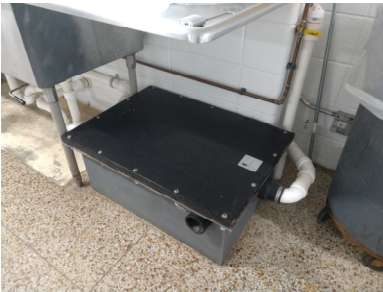
- a. *Expected life span 10-15 years.*
- b. *Current Condition - Good*
- c. Sewer size could not be confirmed at time of inspection.
- d. Piping system material is Cast Iron and PVC.
- e. Piping system is in fair condition.
- f. Grease interceptors location could not be confirmed at time of inspection.
- g. Solid waste interceptors are not present.

Grease Interceptor

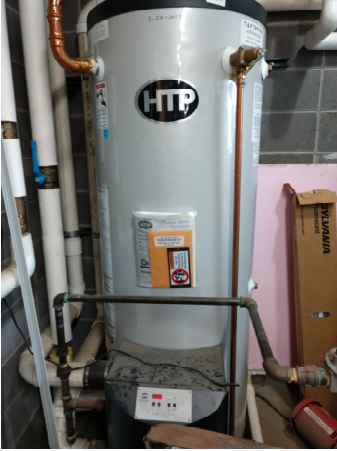
Gas Water Heater

- a. *Life Expectancy – 10-15 years*
- b. *Current Condition – Good / Fair*
- c. Water Softener(s) –serving hot water system only.
 - i. 1qty. 75 gpm.
 - ii. Poor condition.
- d. Gas Water Heater(s)
 - i. 1qty. 100 gal.
 - ii. 120 degree storage temperature.

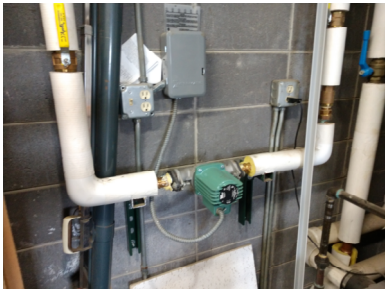
Circulating Pump

- iii. Fair Condition
- e. Circulator Pump(s)
 - i. 1qty. 3 gpm.
 - ii. Fair condition.

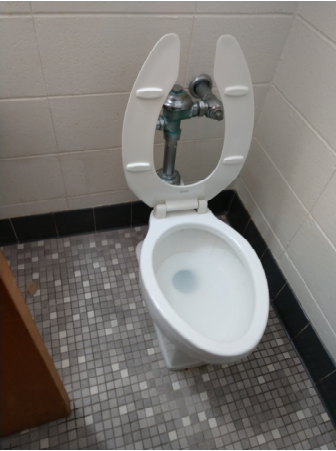
Old Water Closet

- 1) Provide sensor operated flush valves and faucets in toilet rooms.
- 2) Provide all new plumbing fixtures and trim accessories.
- 3) Provide wall mounted fixture where possible in toilet rooms.
- 4) Provide floor drains with trap seal protection in all toilet rooms.

- 5) Replace non ADA compliant fixtures with ADA compliant fixtures.
- 6) Provide solid interceptors at art sink.
- 7) Provide monthly testing of all emergency fixtures.
- 8) Provide emergency fixtures in science rooms.
- 9) Provide emergency fixtures in shop areas.

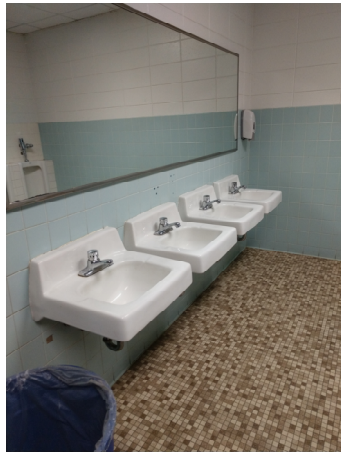
Lavatories

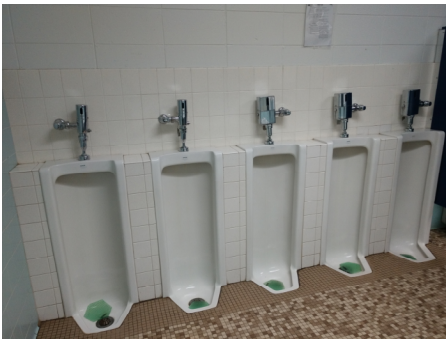
Urinals

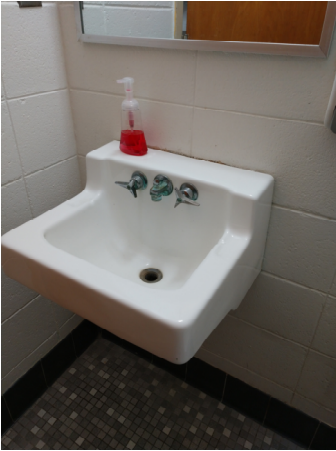
Old Lavatories
